May 1, 2009

Supersedes FLASH 04-01-FL

Wiring of T-8 lighting

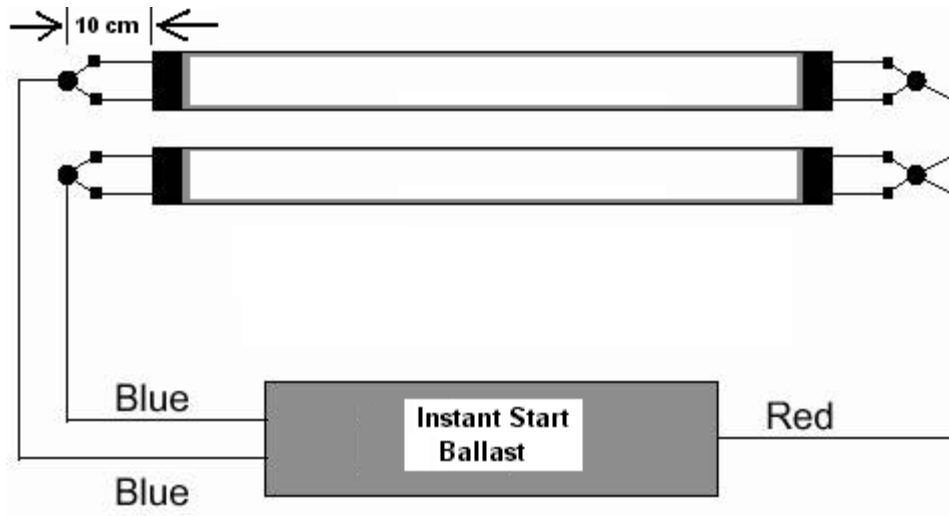
Figure F1 shows correct installation method. Two wires of the each lamp holder are recurred to be connected together prior to connecting them to the appropriate single lead of the instant start-ballast. Check that all lamp holder contacts are in good condition and show no signs of arcing or pitting.

Figure F1 – Correct wiring method

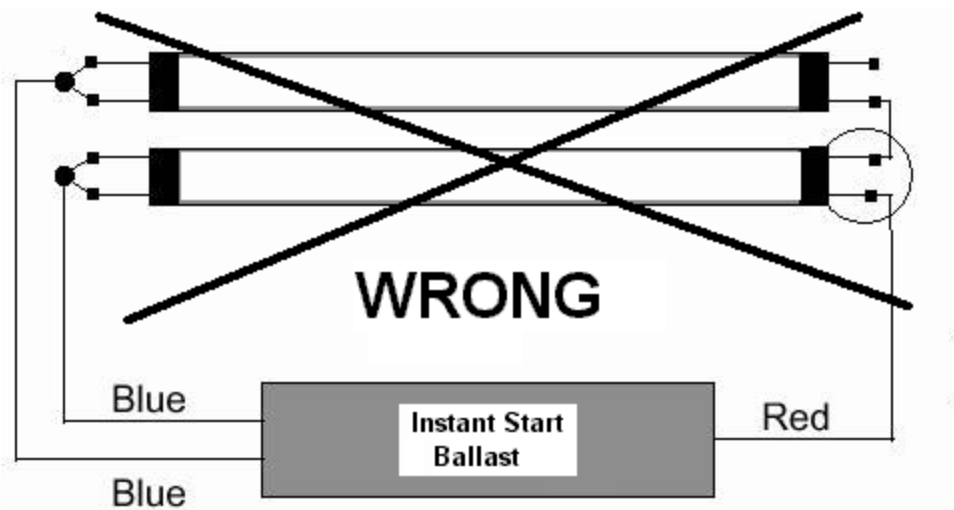
Figure F2 shows incorrect and not acceptable wiring method. This method uses T-8-bi-pin instant-start-lamp holders, which have a factory-installed jumper between the two lamp contacts.

No other wiring configuration is recommended. Incorrect wiring configurations allow excessive current to pass through the lamp(s) cathodes, potentially overheating the lamp base and the lamp holder excessively, resulting in lamp holder deformation, melting or charring and failure.

Figure F2 - Incorrect and not acceptable of wiring method or its electrical equivalent
