Electrical Distribution Safety

DISTRIBUTION COMPANY AWARENESS:

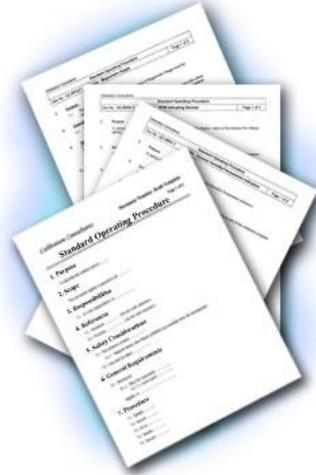
While installing a 3 phase transformer for a customer owned service the neutral conductor (indicated with white markings) was connected by the electrician to the secondary side of a phase conductor (also indicated with white markings). When the customer service was energized it created a fault on the distributor's white phase to ground. After the LDC reviewed the incident a corrective action to update the Standard Operating Procedure was undertaken to clearly define the roles, timing and responsibilities of different stakeholders.

LDC staff is to work on the high voltage conductor and the LDC owned transformer. The electrician (or approved qualified contractor) will perform all necessary secondary work including terminations, splices and training of cables into place of connection. LDC staff will bolt the conductors onto the secondary place of connection.

LDCs review their Standard Operating Procedures to ensure connections are made safely, correctly and that the stakeholder's roles are clearly defined.
