### Electrical Distribution Safety

**ADDITIONAL INFORMATION:** If you can provide additional information on this Bulletin or any other Utility issue, please contact ESA to share your experiences. Additional information requests, and follow-up information, may be directed to ESA. Please be prepared to quote Bulletin “DSB-03/08”.

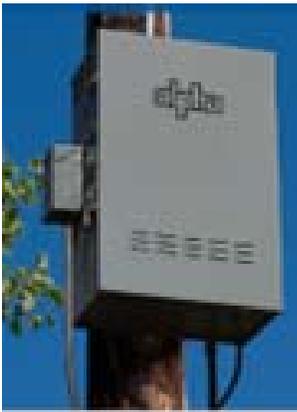
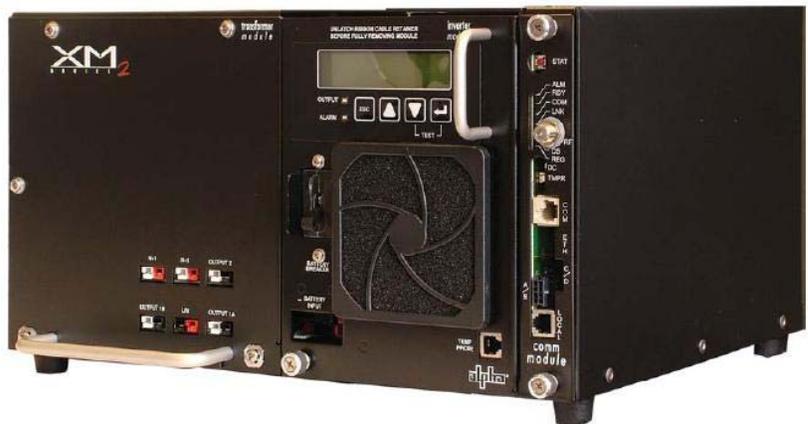
During a planned outage to relocate an LDC owned pole mounted transformer, an LDC power line worker received an 8,000V shock from the primary lead of the isolated transformer. ESA (under the new Product Safety regulatory regime) contacted the Certification Agency and the manufacturer to initiate the investigation. There were a couple of causal factors determined by the manufacturer which contributed to the failure of equipment. Under the new product safety regulation for “code side” equipment the manufacturer was required to provide this information to ESA along with an action plan to prevent future occurrences.

There was a connection path which back fed from the Power Supply through the utility meter, to the closed main switch, which was mounted on the pole. This in turn energized the secondary tap of the LDC transformer which stepped up the voltage from 140 to 8000 volts on the primary transformer bushing that the power line worker relocating. During standby mode these units should not exhibit any voltage on the plug end.

Crews need to be aware of potential back feed from Uninterruptible Power Supplies (UPS). Crews should also be aware of any other means of back feeds such as portable generators.

- LDC’s should create a procedure to verify any possible back feeds through the distribution lines from other sources of energy.
