Electrical Distribution Safety

DISTRIBUTION COMPANY AWARENESS:

Information requests and follow-up may be directed to ESA at Utility.Regulations@ElectricalSafety.on.ca. For questions on this bulletin please be prepared to quote Bulletin "DSB-05/11".

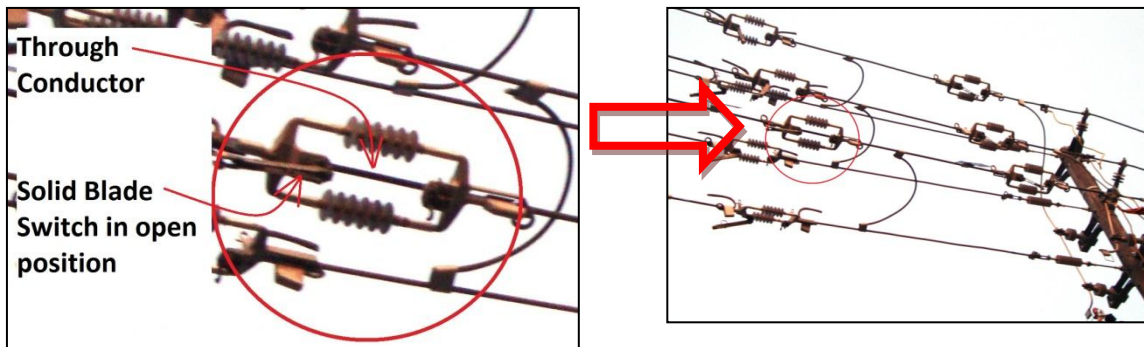
Prior to replacing the fuse assembly, one member of the crew opened 6 other in-line solid blade switches to expand the safe work zone unaware that the lower phase conductor was still energized even though the switch was in the open position.

Normally, there are causal factors involved for any incident to occur. One of the causal factors in this incident was a mistake at the time of the original installation. The conductor between the in-line solid blade switch was not cut, therefore the energy by-passed the open point of the switch.

Crews should examine any existing installation for any errors such as the conductor running through the in-line solid blade switch allowing the flow of energy to bypass the switch blade when in the open position.

Prior to operating of the in-line solid blade switch, crews should inspect the switch to ensure the conductor has been cut.
