**Electrical Distribution Safety**

Information requests and follow-up may be directed to ESA at [Utility.Regulations@ElectricalSafety.on.ca](mailto:Utility.Regulations@ElectricalSafety.on.ca). For questions on this bulletin please be prepared to quote Bulletin "DSB-07/11".

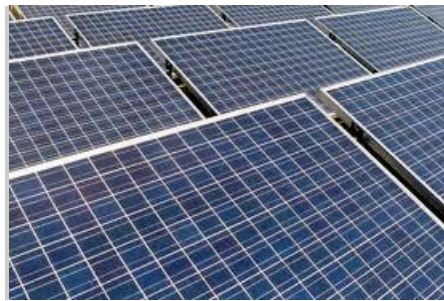
Recently a shutdown was scheduled for preventative maintenance of a 600 Volt service switchboard. The LDC was required to be on site to isolate and de-energize the pad mounted transformer and secondary cables. The Service Contractor turned off the main breaker and the LDC isolated the primary at the pad mounted transformer. The crew conducted a voltage check and measured potential at the secondary terminals of the transformer. The crew and service contractor were unaware there was an embedded photovoltaic (PV) system in place connected to the line side of the main service.

The Ontario Electrical Safety Code (OESC) rule 84-008 requires a distributed generation system to automatically disconnect electric power production sources when there is a loss of power from the supply authority. In the case of this near miss incident, the solar inverter's "anti-islanding" feature failed to fully disconnect the energy produced from the PV system.

Prior to work on equipment, crews should be made aware of embedded generators at customer facilities. The utility disconnect switch required by the LDC should be used as the disconnecting means. PV system outputs may become energized at anytime with changing sunlight conditions.

LDC's review operating procedures and identify their customers who have embedded generation system.
