October 2016

Supersedes 09-03-FL

Luminaires retrofitted with T8 fluorescent tubes

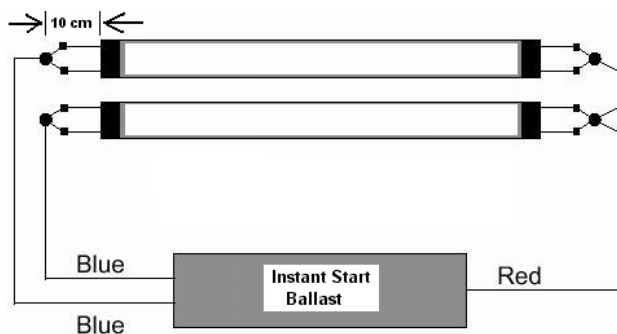
Figure F1 – Correct wiring method

Figure F1 shows correct wiring configuration. Check that all lamp holder contacts are in good condition and show no signs of arcing or pitting.

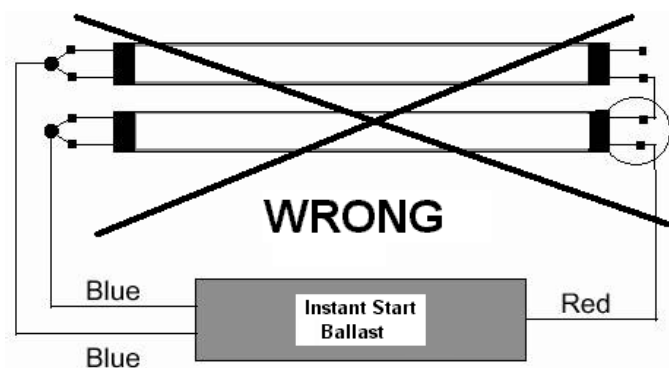
Figure F2 - Incorrect and not acceptable wiring method or its electrical equivalent

Figure F2 shows incorrect and unacceptable wiring configuration. This method uses T8, bi-pin, instant-start lamp holders, which have a factory installed jumper between the two lamp contacts.

No other wiring configuration is recommended. Incorrect wiring configurations allow excessive current to pass through the lamp(s) cathodes, potentially overheating the lamp base and the lamp holder excessively, resulting in lamp holder deformation, melting or charring and failure.
