October 2016

Supersedes 13-01-FL

Polarity identification for photovoltaic dc system conductors

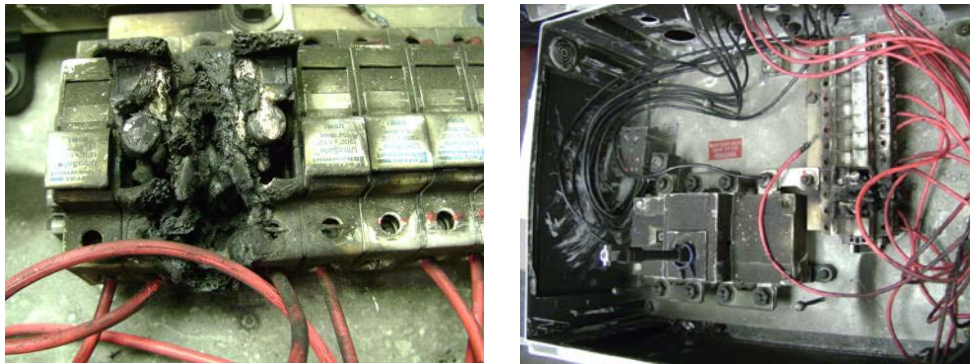
ESA has been involved in several fire investigations that resulted when polarity of PV (dc) source and/or output circuit wiring was accidentally reversed during installation. One of the main contributing factors was the lack of marking and/ or improper field marking of conductors which presents many opportunities for errors and consequently dangerous failures.

In Ontario we have experienced failure during installations that are suspected to have been caused by increased potential when a single array's wiring was reversed to a combiner box. Minor contaminants, such as moisture or dirt, have started self sustaining dc arcing faults, even with the fuses in the open position.

Photo F1 below shows an example of PV equipment (combiner box) failure as a result of reversed PV source circuit polarity.

Photo F1 – Accident resulted when polarity of dc sources was reversed

The Ontario Electrical Safety Code (OESC) Rule 64-212 requires dc Photovoltaic circuit conductors to be coloured or coded to identify polarity, see Photo F2.

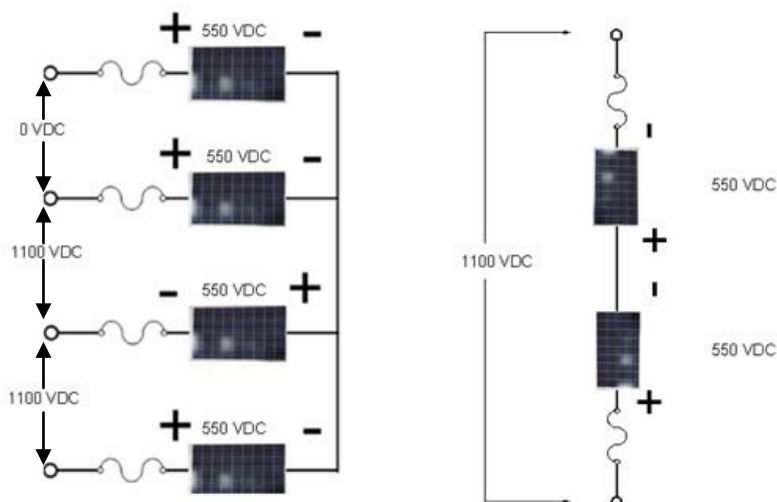
Unlike traditional ac systems where connection of incorrectly identified conductors will cause reversal of motors or an overcurrent device to operate, reversal of dc sources can create series circuits that will produce voltages well in excess of the rated system voltage. Diagram F1 below explains the circuit analogy of a reversed PV source circuit polarity.

Diagram F1 – Reversed polarity of dc sources

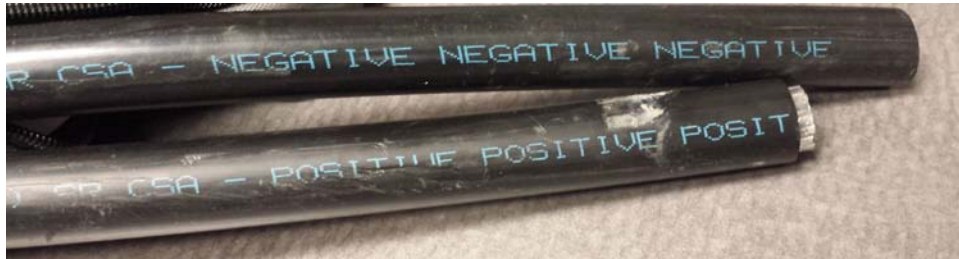
Photo F2 – Example of the required marking to identify polarity
