June 2019

Supersedes 16-24-FL

## Polarity identification for photovoltaic dc system conductors

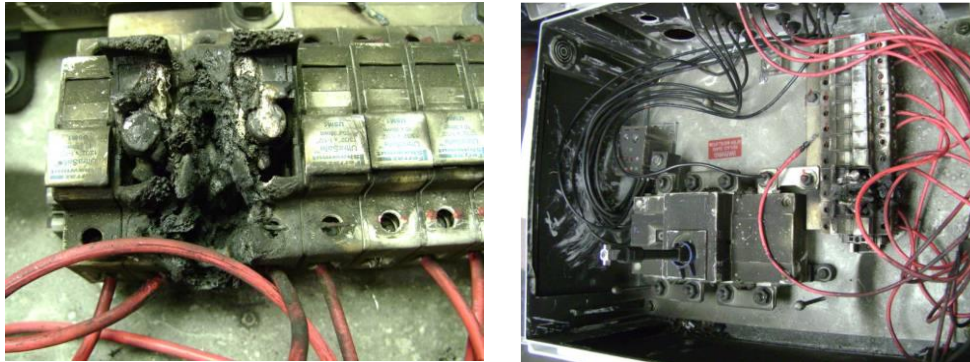
ESA has been involved in several fire investigations that resulted when polarity of PV (dc) source and/or output circuit wiring was accidentally reversed during installation. One of the main contributing factors was the lack of marking and/ or improper field marking of conductors which presents many opportunities for errors and consequently dangerous failures.

In Ontario we have experienced failure during installations that are suspected to have been caused by increased potential when a single array's wiring was reversed to a combiner box. Minor contaminants, such as moisture or dirt, have started self sustaining dc arcing faults, even with the fuses in the open position.

Photo F1 below shows an example of PV equipment (combiner box) failure as a result of reversed PV source circuit polarity.

**Photo F1 – Accident resulted when polarity of dc sources was reversed**

The Ontario Electrical Safety Code (OESC) Rule 64-212 requires dc Photovoltaic circuit conductors to be coloured or coded to identify polarity, see Photo F2.

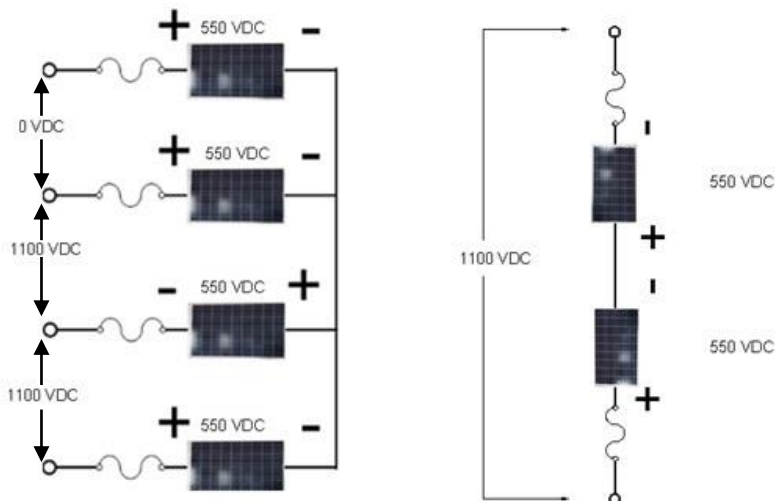
Unlike traditional ac systems where connection of incorrectly identified conductors will cause reversal of motors or an overcurrent device to operate, reversal of dc sources can create series circuits that will produce voltages well in excess of the rated system voltage. Diagram F1 below explains the circuit analogy of a reversed PV source circuit polarity.

**Diagram F1 – Reversed polarity of dc sources**

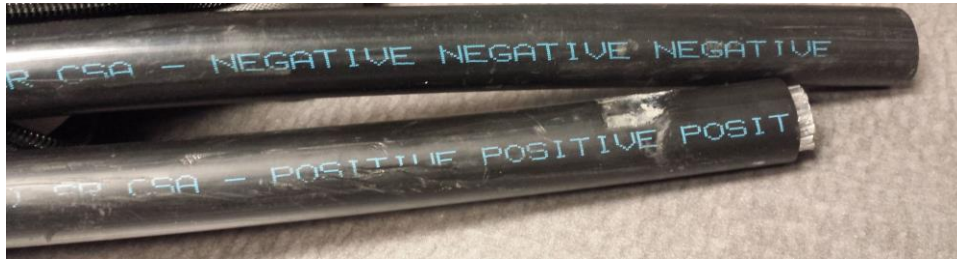
**Photo F2 – Example of the required marking to identify polarity**
