February 29, 2008

Eaton/ Cutler-Hammer Recalls Rotary and Toggle Disconnect Switches

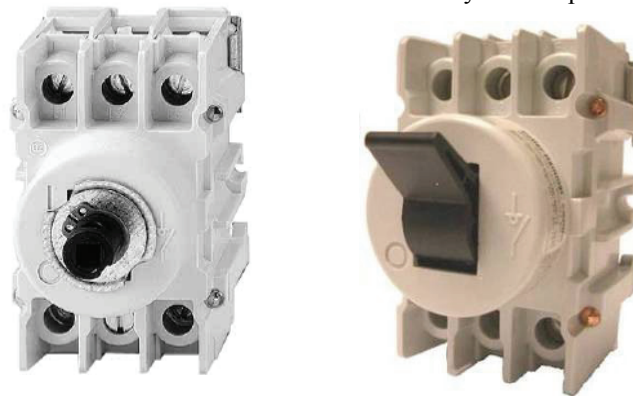
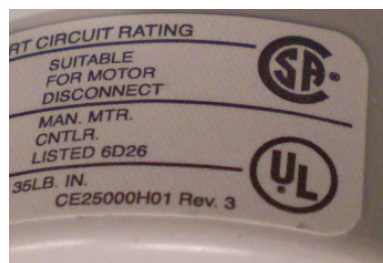
Hazard: A user could move the switch or the disconnect handle to the “OFF” position and if the switch is defective, the contacts could remain in a closed condition. This condition could result in death, serious personal injury or property damage.

Affected Rotary and Toggle Disconnect Switches

Remedy: Owners and operators of these recalled switches should take steps to initiate replacement of the recalled component switches immediately by contacting the supplier from whom they were purchased, for instructions on return of the product and for a replacement disconnect switch.
