## Electrical Distribution Safety

If you can provide additional information on this Bulletin or any other Utility issue, please contact ESA to share your experiences. Additional information requests, and follow-up information, may be directed to ESA. Please be prepared to quote Bulletin "DIB-08/09".

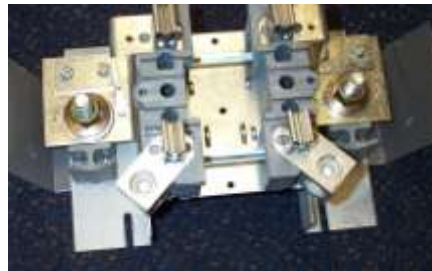
The LDC is at a residential customer's house to change the meter. After pulling the meter off the meter base the LDC employee finds one of the meter lugs is broken inside the meterbase and therefore cannot replace the meter. In order to restore power to the customer the meter jaw(s) will require replacement.

No. Meter base socket retrofit, using parts as shown below, is work covered by the Ontario Electrical Safety Code (OESC) and must follow all requirements detailed in that code. Upon discovery of a broken meter base, the utility employee should contact an Electrical Contracting Business with an Electrical Contractor Licence working under a Master Electrician Licence, or the home owner should be made aware of the issue so arrangements for a Licenced Electrical Contractor to implement repairs.

The Electrical Contracting Business could include the utility's licenced affiliate company.
