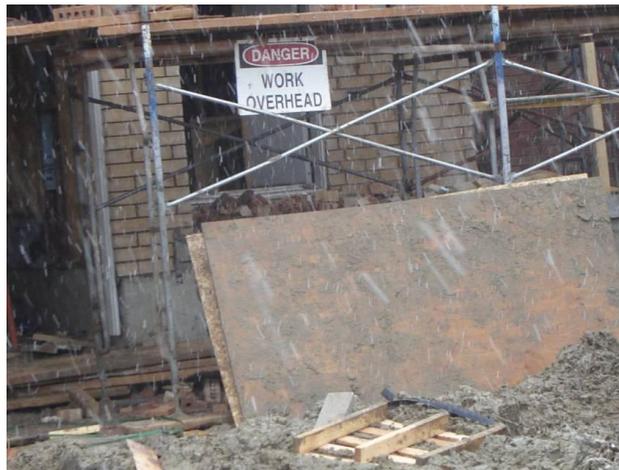
1. Areas are not safely secured or readily accessible for inspection

Often inspectors arrive on site to perform an inspection and find the inspection area is either locked, requires a ladder to access, is located in a basement with no stairs installed, or other reasons that deem the area “inaccessible.” This represents more than 50 per cent of the defects issued related to Rule 2-004.

All requirements for an inspection must be met prior to arranging for an inspection to avoid defects, additional costs and project delays.
