Aluminum wiring in residential installations

Issues with aluminum wiring

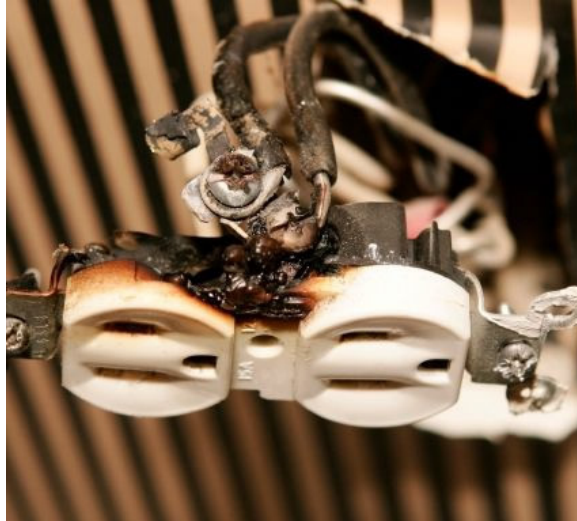
Photo F1 – Failure of aluminum wiring terminations

Reported problems with aluminum wiring have been related to the overheating and failure of aluminum wiring terminations. This is due to the tendency for aluminum to oxidize and its incompatibility with devices designed for use with copper wiring. Warm

cover plates or discolouration of switches or receptacles, signs of arcing within switches or receptacles as per photo F1, flickering lights, or the smell of hot plastic insulation may be evidence of these problems.

As mentioned above, where problems exist with aluminum wiring they are usually found at termination points. This necessitates the opening of all outlets (receptacles, switches, fixtures, appliance connections and in the panelboard) and visually inspecting terminations for signs of failure and overheating without removing or disturbing the devices or wiring. There should be no signs of overheating such as darkened or discoloured connections, melted insulation, etc.

Where problems are found the damaged aluminum conductor should be cut back to remove the damaged portion and then the necessary repairs made.

If an owner is aware or has discovered that the house is wired with aluminum wiring and the original devices are not marked as suitable for aluminum wiring, there is a potential for failure which could lead to a fire, as per Photo F1. Aluminum-wired connections have been known to fail and overheat without any prior indications or problems. Do not wait for signs of overheating of the termination or signs of arcing within switches and receptacles. ESA strongly recommends eliminating a hazard by replacing the original devices with aluminum rated and properly marked devices (or have copper tails installed).

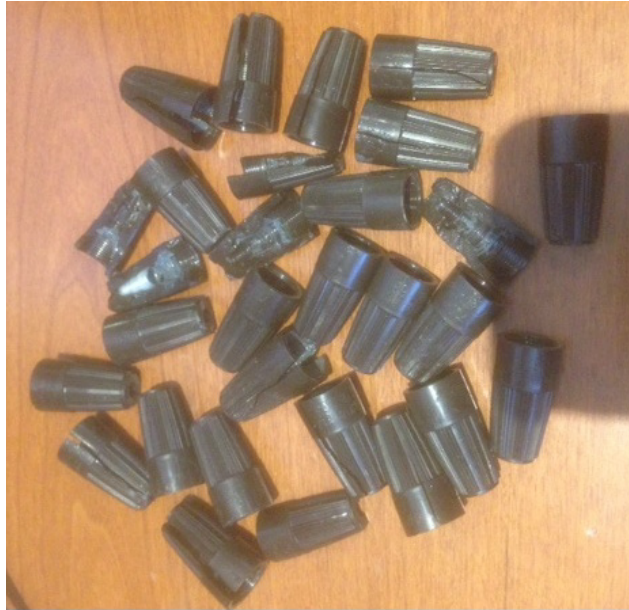
Figure F2 – Non-Petroleum based inhibitor failures

It has been brought to the attention of ESA that the excess use of **non-petroleum** based inhibitors may result in the failure of approved wire connectors. Figure F2 shows

an example of a failure when non-petroleum based inhibitor was used for copper to aluminum connections. The “Oxide Inhibiting compound” and connector manufacturers’ shall be consulted to ensure the compound used is appropriate for the application.

Unless the termination or splice is approved and so marked for use without Oxide Inhibitors, OESC Rule 12-118 2) requires a joint compound, capable of penetrating the oxide film and preventing its reforming, be used with **stranded** aluminum conductor connections.

The compound is conductive and should be used sparingly and any excess compound should be removed.
