DISTRIBUTION COMPANY AWARENESS

This bulletin is intended to provide guidance to Local Distribution Companies (LDC), during emergencies only, when LDC line crews need to decide whether to disconnect a residential customer's service or leave the service energized.

Information requests and follow-up may be directed to ESA at Utility.Regulations@ElectricalSafety.on.ca. For questions on this bulletin please be prepared to quote Bulletin "DB-05/17".

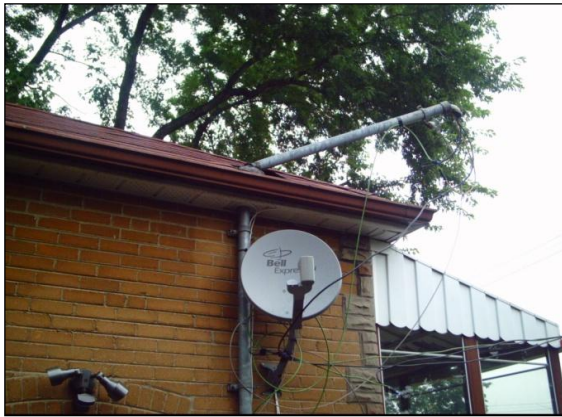
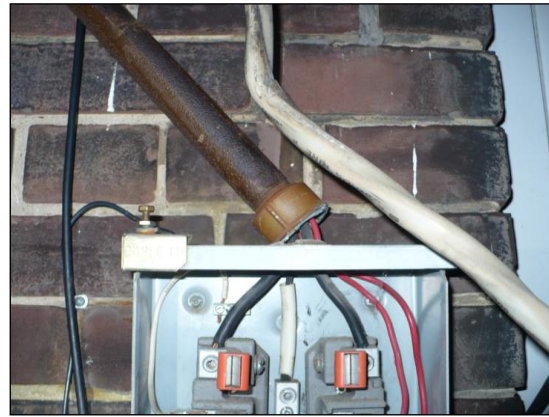
Example 1: Significantly bent metallic customer service mast

When a rigid metallic mast or customer service conduit is broken or significantly bent, the integrity of the conductors may be compromised due to sharp edges inside the mast. In this case the following direction should be taken:

1. For safety reasons the LDC should immediately disconnect the service. No attempt shall be made to straighten the mast or customer service conduit.

2. The LDC may provide a temporary feed directly to the meter base. ESA recommends the following conditions be met if a temporary feed is provided.

- Customer service conductors entering the meter base have a suitable box connector to avoid exposing live parts to the public;
- Temporary supply service conductors are clearly marked and adequately barriered;
- The homeowner has been made aware of the temporary supply service on their property;
- Bare neutral conductors are not exposed or accessible to members of the public; and
- An ESA Hazard Notification has been or will be initiated and the customer has been or will be advised that repairs are required.

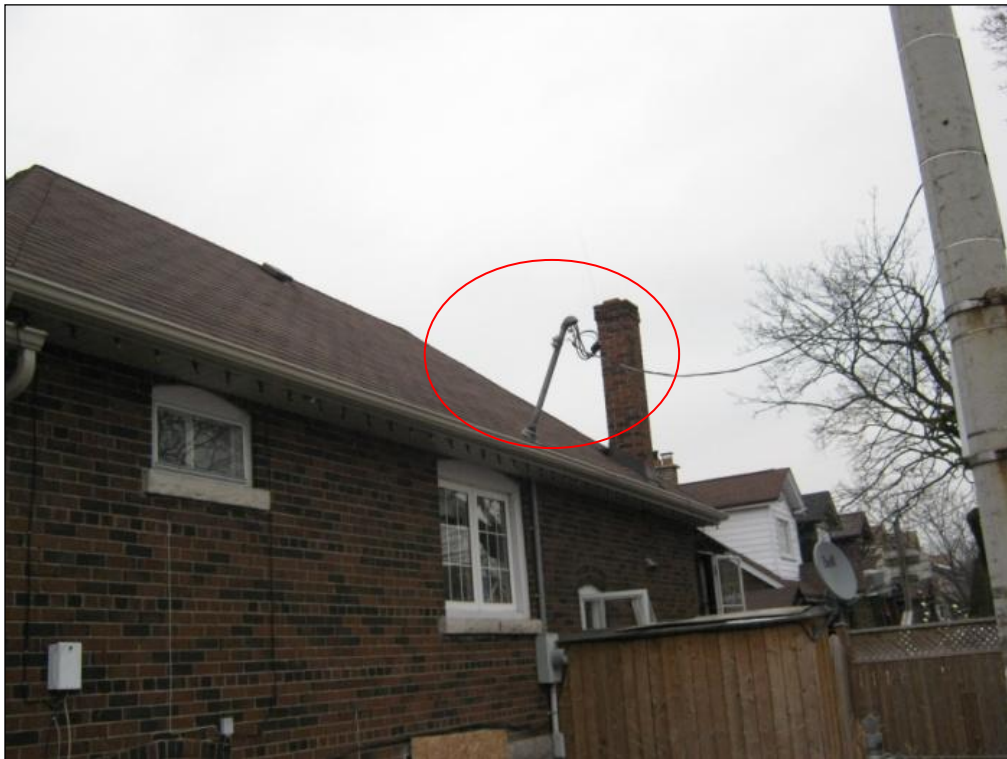
Example 2: Slightly bent metallic customer service mast

If a rigid metallic mast or customer service conduit is slightly bent, not cracked, and the bend is unlikely to damage the customer service conductor, the service may be left energized if it meets the following conditions:

- The terminals/supports inside the meter base are not damaged;
- Overhead conductors are barriered such that unauthorized persons do not come into contact with them or draw arcs under reasonably foreseeable circumstances; and
- An ESA Hazard Notification has been or will be initiated and the customer has been or will be advised that repairs are required.

In order to have damaged customer-owned equipment inspected by ESA, the LDC should report the damaged customer service to ESA by notifying the ESA Customer Service Centre so that an ESA Hazard Notification will be created. ESA recommends that the LDC also advise the customer that repairs are required (e.g. Customer Advisory Form).

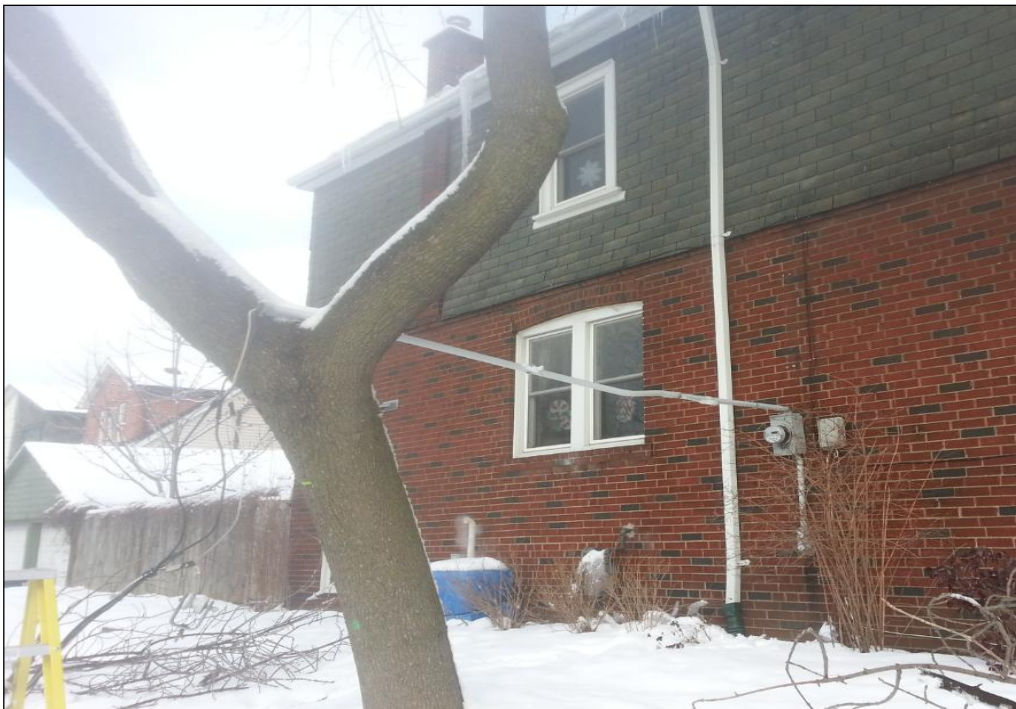
Example 3: Damaged non-metallic (PVC) customer service conduit

If a non-metallic (PVC) customer service conduit is damaged, either broken or pulled apart, the service may be left energized if it meets the following conditions:

- The conductor insulation is intact;
- The terminals/supports inside the meter base are not damaged;
- Overhead conductors are barriered such that unauthorized persons do not come into contact with them or draw arcs under reasonably foreseeable circumstances; and
- An ESA Hazard Notification has been or will be initiated and the customer has been or will be advised that repairs are required.

In order to have damaged customer-owned equipment inspected by ESA, the LDC should report the damaged customer service to ESA by notifying the ESA Customer Service Centre so that an ESA Hazard Notification will be created. ESA recommends that the LDC also advise the customer that repairs are required (e.g. Customer Advisory Form).

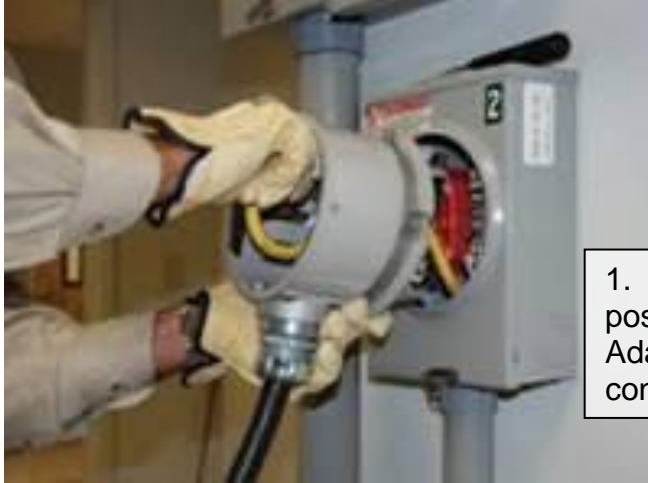
1. ESA recommends where possible to use Meter Socket Adapters for temporary connections.

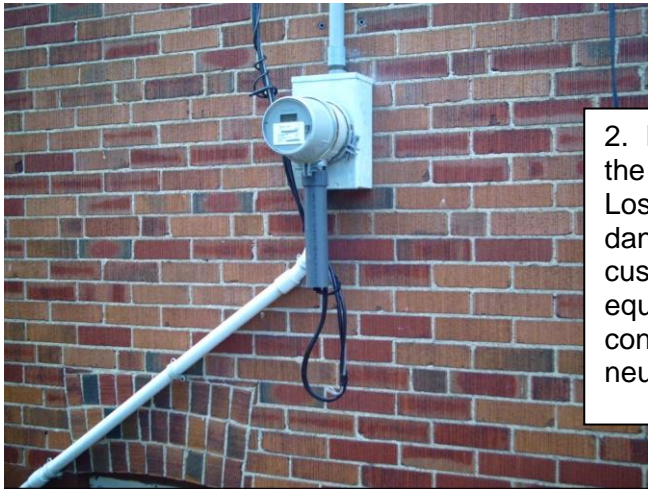
2. It is imperative that the continuity of the neutral conductor be maintained. Loss of neutral continuity may create dangerous voltage imbalances on the customer's service and distribution equipment. The service ground conductor shall not be used as a neutral, even on a temporary basis.
