Electrical Distribution Safety

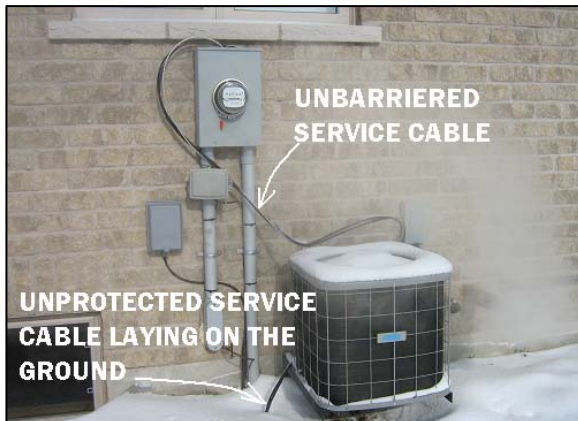
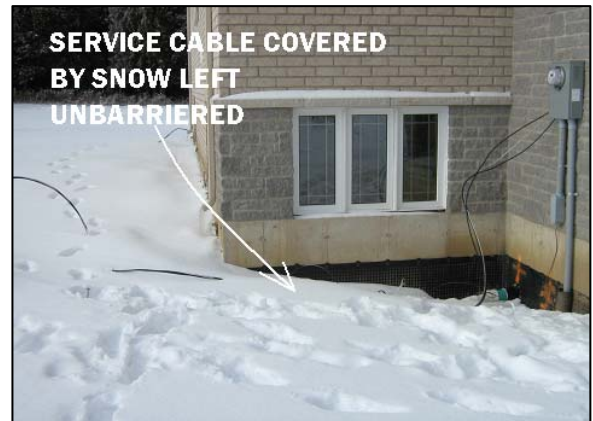
Common hazards ESA has found are:

- Service cables laid on the ground unprotected and unbarriered
- Unbarriered overhead service cable without adequate clearance.
- Service cables entering side of meter base with no box connector exposing live terminals to the public
- Temporary service cable not identified and barriered
- Homeowner unaware of temporary service on residential property
- Members of the public exposed to accessible bare neutral conductor

- LDCs create standards and practices for the installation of temporary services or follow applicable clauses in OESC section 66 or section 76 and
- Review the definition of “No undue hazard” or “site left in safe condition” (as per the LDC Construction Verification Program) with staff involved in the installation of temporary services and staff who inspect the installation.
