March 2017

Supersedes 08-01-FL

Electrical hazards found at sports fields

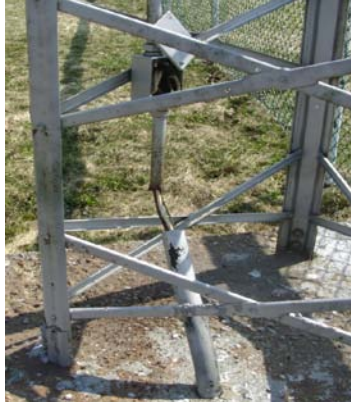
- Some towers used to support lighting are in a deteriorated condition.
- Original installation may have been modified, exposing energized conductors (See Photo F1).
- Box covers are missing or improperly installed.
- Electrical Metallic Tubing (EMT) was commonly used a number of years ago as raceway for electrical wiring in outdoor installations which included sports fields.
 - EMT can become rusted and break where it has been used in exposed installations.
 - EMT may shear off where it exits concrete as it deteriorates.
 - Damaged and deteriorated EMT may pose a shock hazard through loss of bonding continuity.

Photo F1 – Deteriorated and incomplete conduit system with exposed conductors

Once deterioration or damage is identified, repairs should be made immediately. When making repairs, the requirements of the current revision of the Ontario Electrical Safety Code (OESC) should be considered. When it is necessary to replace all or part of an electrical installation it should be confirmed that any such work complies with the current requirements of the OESC and that an application for inspection (permit) is obtained for the work.

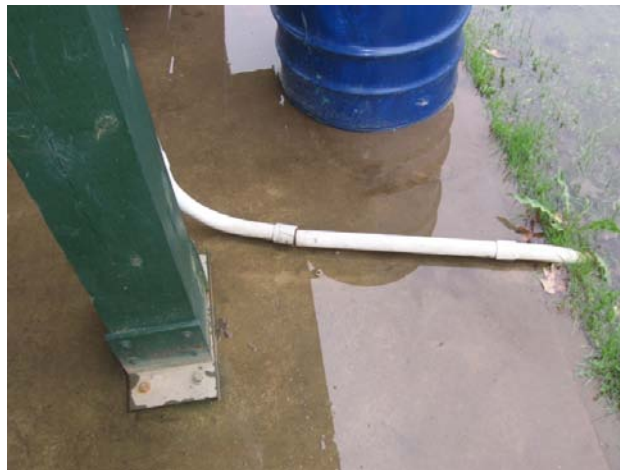
- PVC conduit damaged by snow removal or lawn care equipment, potentially exposing wires.
- Conduits are not protected from ongoing mechanical damage, see Photo F2.
- Conduits concealed by snow during winter months, creating the potential for additional damage.

Photo F2 – Improperly protected conduit (Damaged)

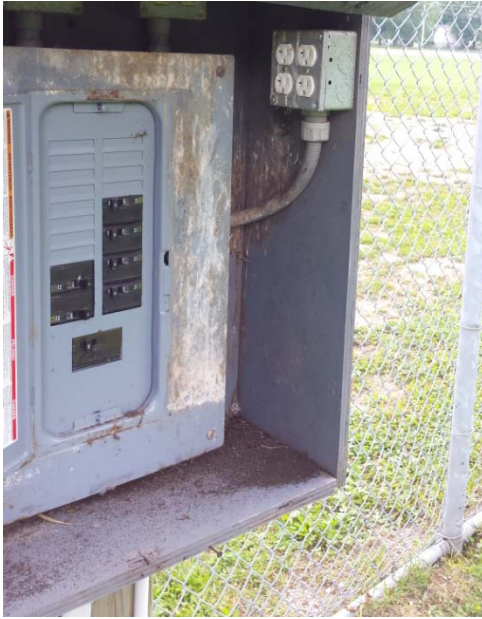
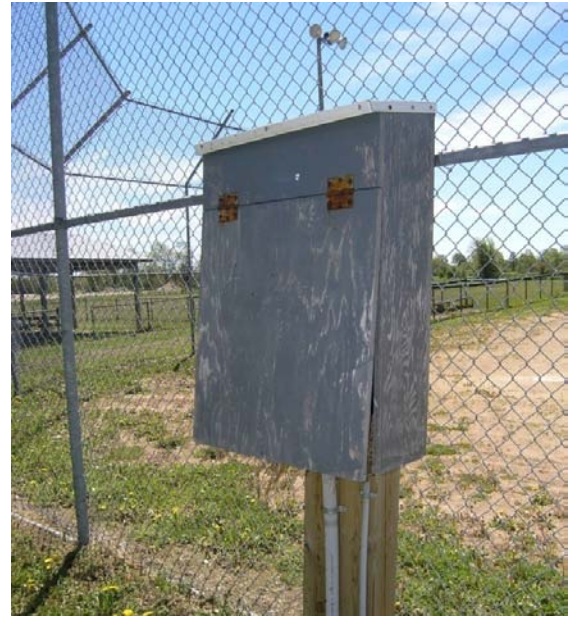
- Electrical panels rusting.
- Electrical panels with unused openings as a result of missing panel fillers which exposes the live bus to anyone putting their hands on or near the panel.
- Electrical panels protected by wooden enclosures which are not weather-proof or are deteriorated.
- Electrical panels are not locked.
- Evidence of animal nesting.

Some of the above conditions are shown on Photo F3 below.

Photo F3 – Accessible and Deteriorated Enclosure
