October 2016

Supersedes 11-03-FL

Installation of communication wiring around electrical equipment

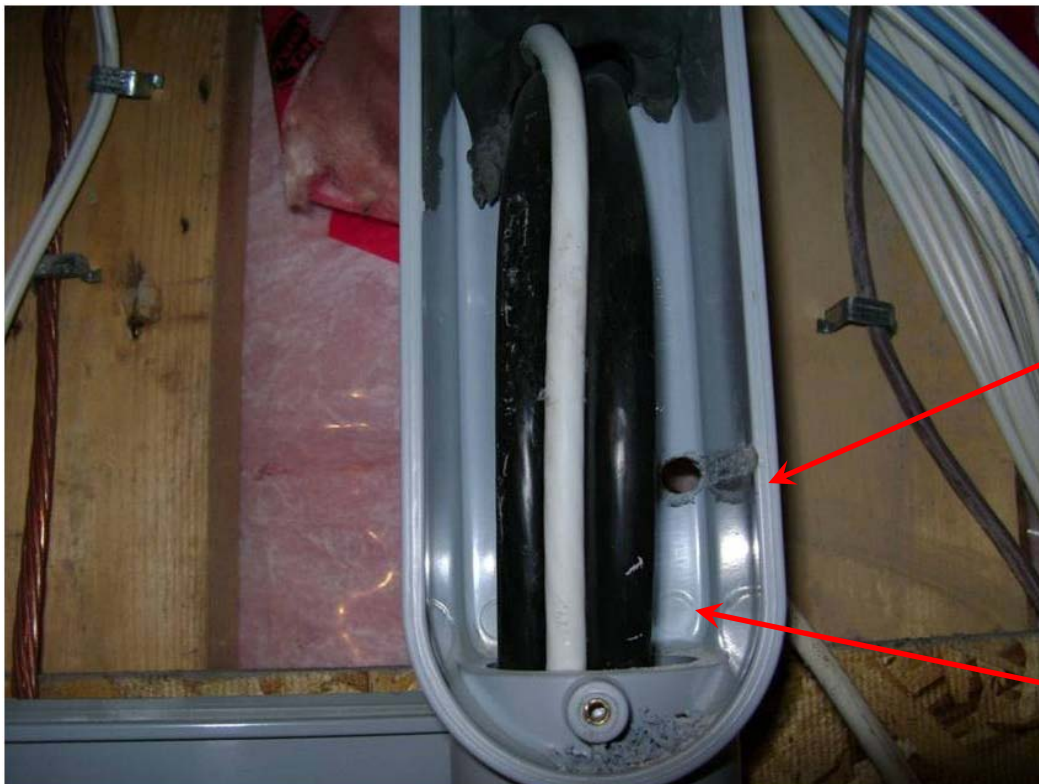
Photo F1

A Cable installer drilled a hole through the wall from the outside, without realizing the hole penetrated into the electrical conduit fitting and almost interacted with the energized wire.

Energized wire

The root cause of these incidents is failure to ensure the area is clear and safe for drilling. These incidents could have been avoided by measuring the inside and outside of the structure where the intended hole is to be located for cable routing.

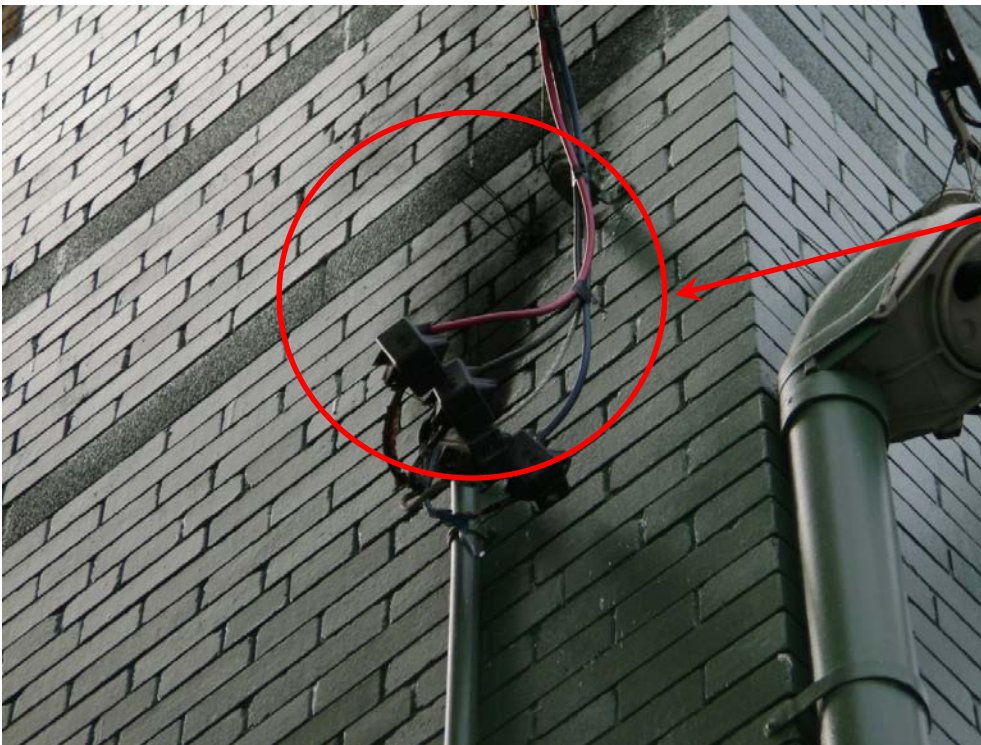
Photo F3

The arc flash went up the conduit and exited at the top of the mast. The arc flash also entered into the building and burnt out the service switch and meter base.
