October 2016

Supersedes 15-02-FL

Aluminum wiring in residential installations

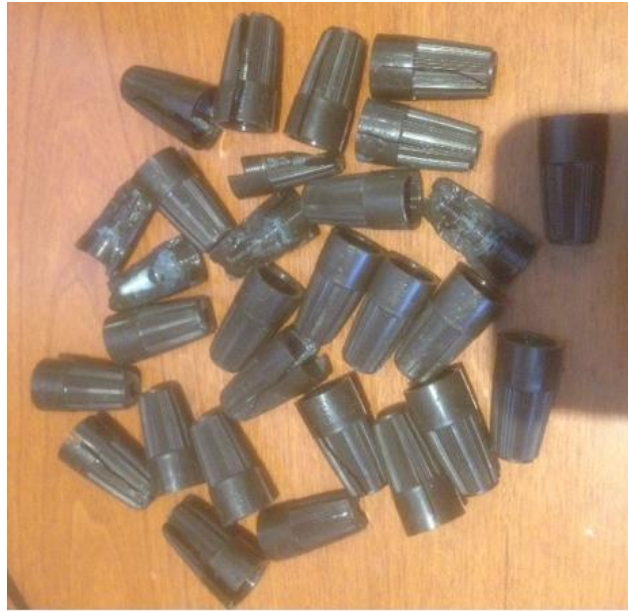
It has been brought to the attention of ESA that the excess use of **non-petroleum** based inhibitors may result in the failure of approved wire connectors. Figure F2 shows an example of a failure when non-petroleum based inhibitor was used for copper to aluminum connections. The “Oxide Inhibiting compound” and connector manufacturers’ shall be consulted to ensure the compound used is appropriate for the application.

Figure F2 – Non-Petroleum based inhibitor failures

Unless the termination or splice is approved and so marked for use without Oxide Inhibitors, OESC Rule 12-118(2) requires a joint compound, capable of penetrating the oxide film and preventing its reforming, be used with **stranded** aluminum conductor connections.

The compound is conductive and should be used sparingly and any excess compound should be removed.
