June 2019

Supersedes 16-23-FL

## Installation of communication wiring around electrical equipment

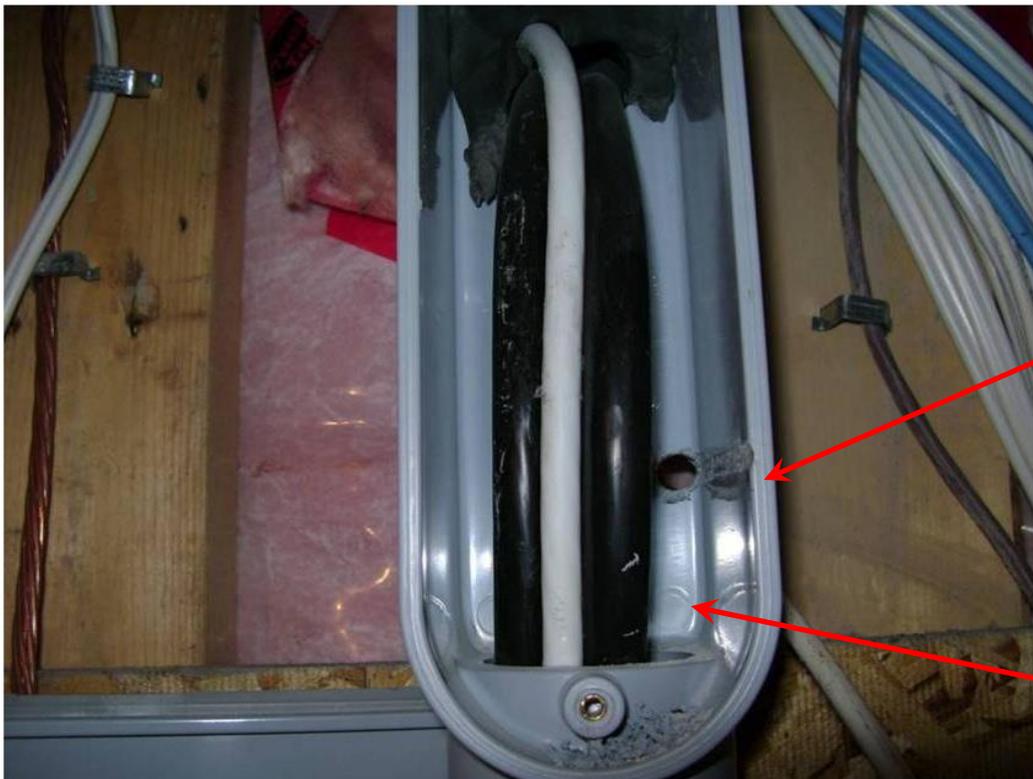
Photo F1

A Cable installer drilled a hole through the wall from the outside, without realizing the hole penetrated into the electrical conduit fitting and almost interacted with the energized wire.

Energized wire

The root cause of these incidents is failure to ensure the area is clear and safe for drilling. These incidents could have been avoided by measuring the inside and outside of the structure where the intended hole is to be located for cable routing.

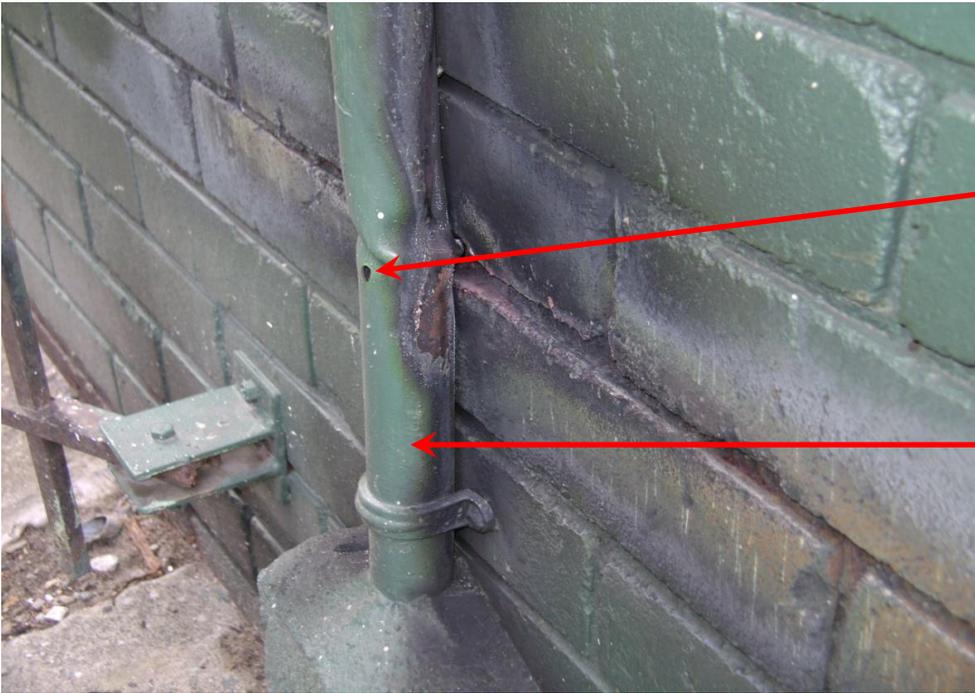
Photo F2

Cable installer drilled a hole from the inside to the outside of a building for a telephone cable and hit the service conduit, causing a significant arc flash.

The service conduit contained a 600 V energized cable.

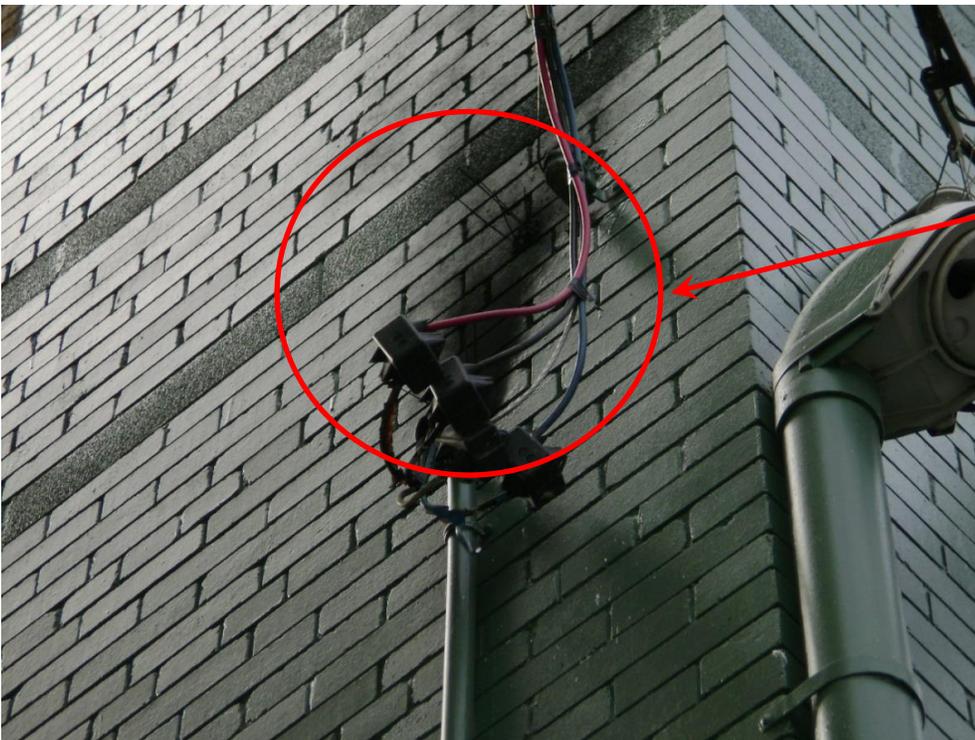
Photo F3

The arc flash went up the conduit and exited at the top of the mast. The arc flash also entered into the building and burnt out the service switch and meter base.

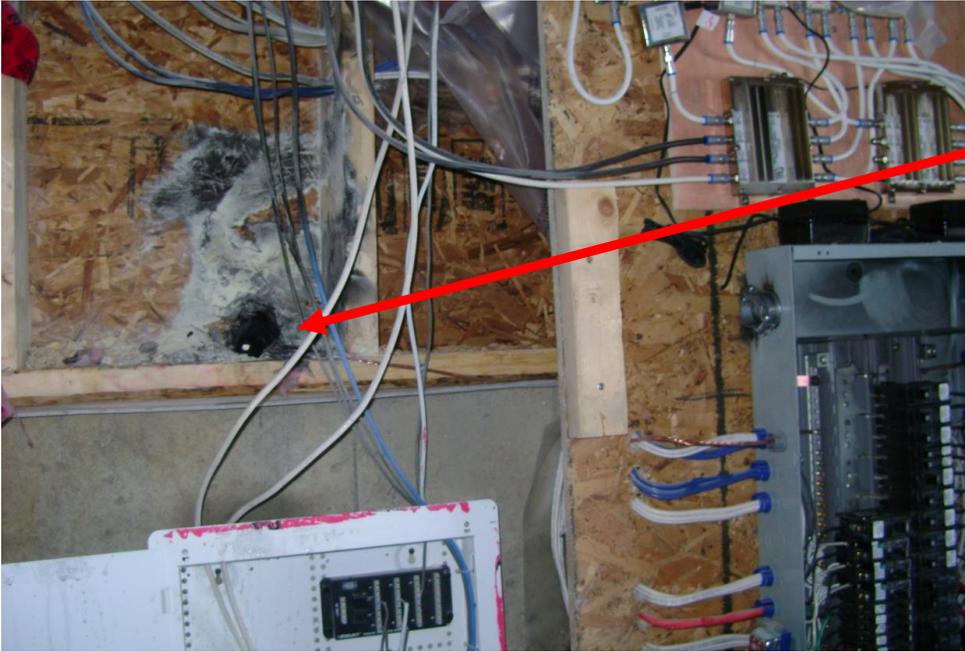
Photo F4

Cable installer drilled through the clay brick of the house beside the service entrance, using a hammer drill. As the drill penetrated the brick it also penetrated the TECK cable. An electric arc started and caused a fire.
