**Electrical Safety Authority
Warns of Potential Shock Hazard Associated with the incorrect
installation of
In-line Fuse Holders**

The Electrical Safety Authority (ESA) is warning end users and contractors about a potential shock hazard associated with the use of Thomas & Betts In-line Fuse Holder Models 65 and 65U.

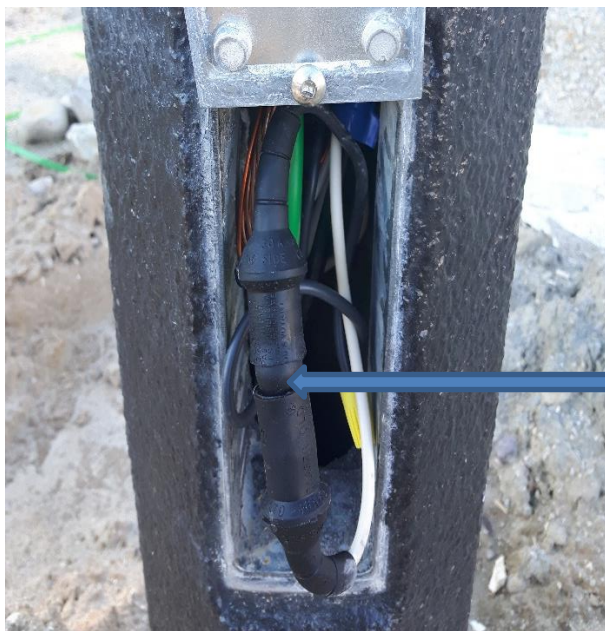
Example of incorrectly assembled Fuse Holder with a wide gap between holder halves.

Wide Gap between fuse holder halves when assembled

End users and contractors are cautioned to ensure that they follow the manufacturer's installation instructions when using the Thomas & Betts In-line Fuse Holder Models 65 and 65U.

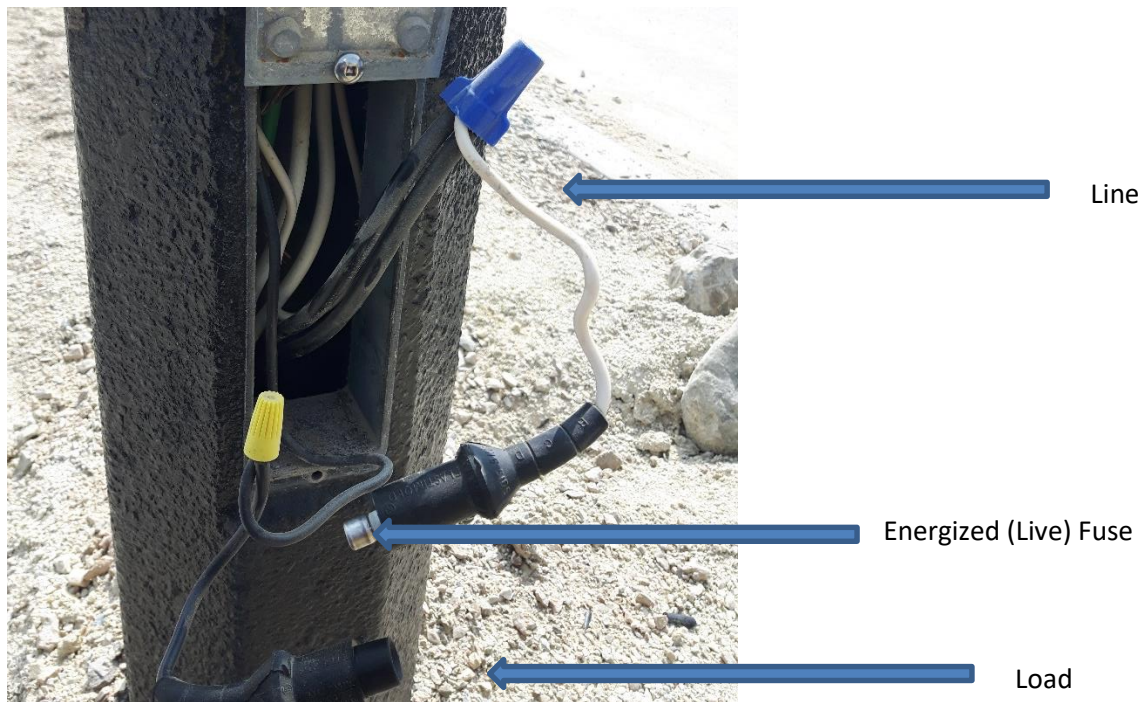
ESA became aware that the fuse remains energized and connected to the line side of the circuit when the two halves are separated during maintenance and examination. This potential hazardous condition occurs when the fuse holder is not assembled in accordance to the accompanying manufacturer's instructions.

Example of energized Fuse due to it remaining on the line side of fuse holder when halves are opened

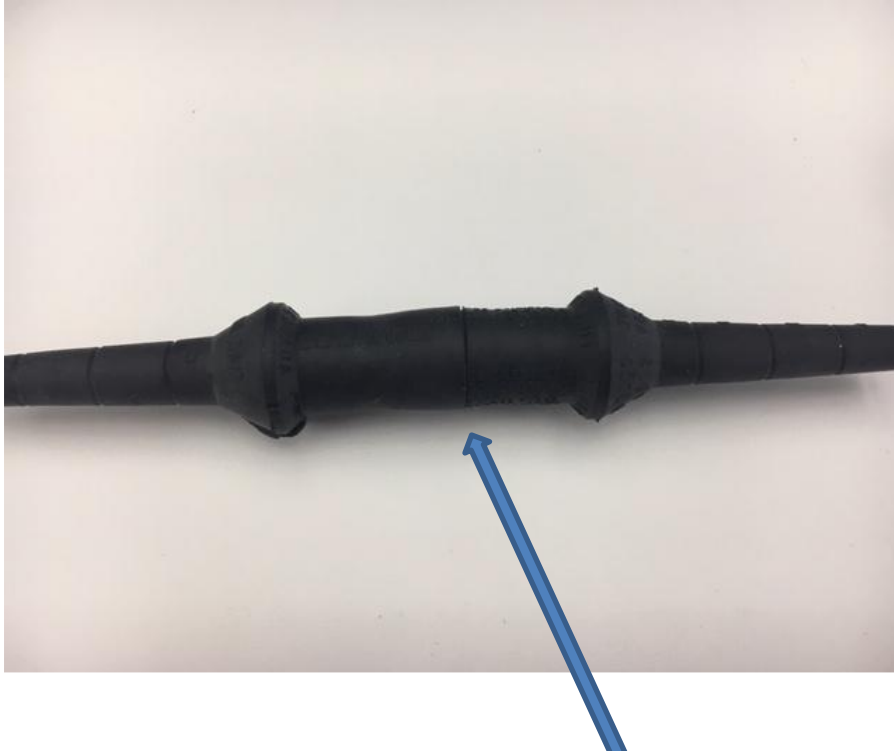
Correctly Assembled Fuse Holder -

When properly mated, the seam between housings should not exceed 1/32 inch as outlined in the manufacturer's instructions
