May 1, 2009

Supersedes FLASH 02-02-FL

Isolated ground receptacle connected wrong

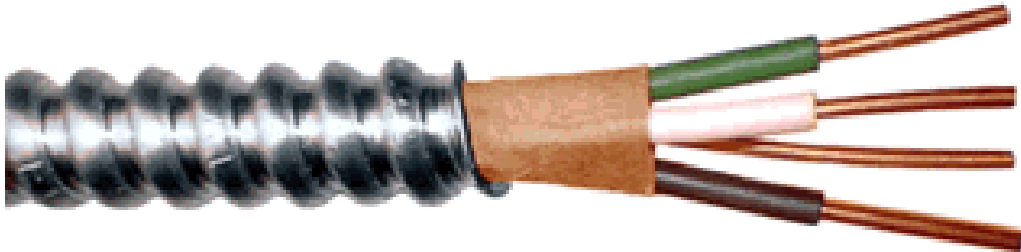
Photo F2 – Cable with both a bare bond and insulated green bond conductors

Checks with many wholesalers, suppliers and manufactures indicate that the proper cable, with both a bare bond and insulated green bond conductors are available (see Photo F2). Installations with taped green bonding conductors will not be accepted, if of #2 or smaller, as per rule 4-036 (1)(b). Please check all of your existing Isolated Ground Receptacles with a proper tester to ensure they have not been altered in this manner.
