**May 1, 2009**

Supersedes FLASH 06-03-FL

## **Aluminum wiring in residential installations**

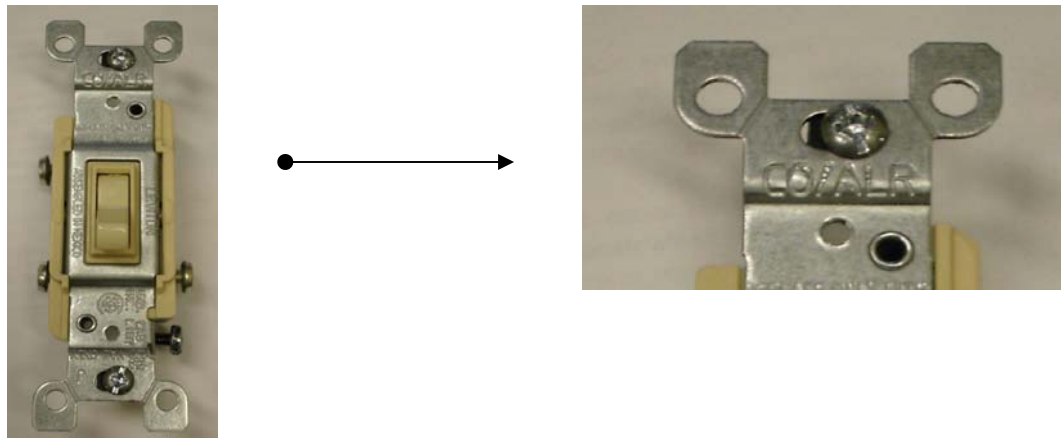
**Photo F1 – Required marking for devices used with aluminum wiring**

All terminations of aluminum conductors shall be to devices marked as per Table F1 and Photo F1; this includes the bare bond conductor as well. Rule 12-118(3) provides two exceptions to this requirement. The first exception is for devices or fixtures with wire leads, in which case the joint between the wire lead and the aluminum conductor shall be made with a wire connector approved for copper to aluminum connections and marked as per Table F1. The second exception is the outlet box bonding screw, which does not require approval for connection of the aluminum bonding conductor.

Replacement receptacles and switches shall be installed in compliance with the Ontario Electrical Safety Code and marked as per Table F1.
