Electrical Distribution Safety

GENERAL STATEMENT:

Two members of the public received an electrical shock; one of whom was critically injured due to an energized submarine cable operating with a corroded concentric neutral. The purpose of this bulletin is to;

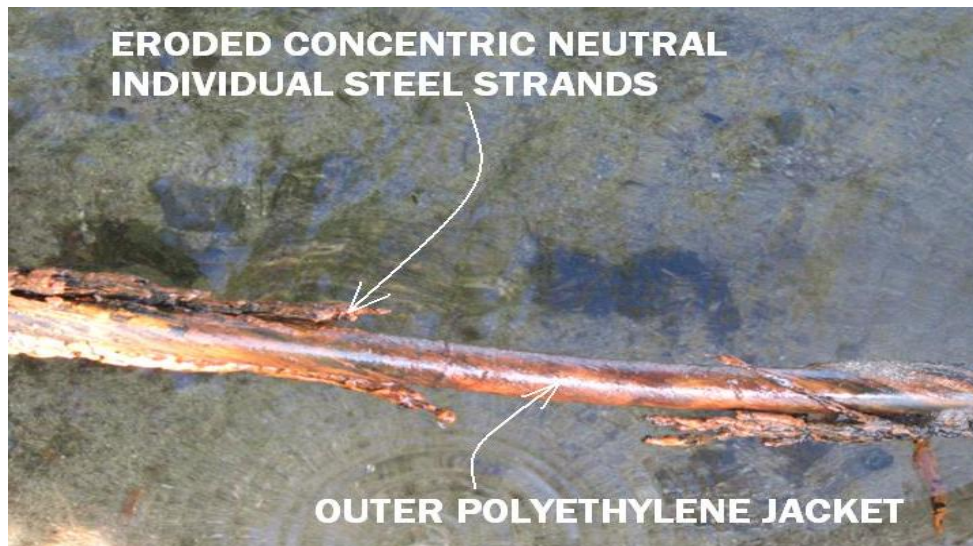
The mode of failure causing the hazard of the submarine cable was the corrosion of the concentric neutral in shallow water near the shoreline. Over time, pH levels in the water, freezing and thawing of the water contributed to the corrosion of the concentric neutral. When the concentric neutral is corroded, water becomes the conductor in place of the concentric neutral resulting in electric shock for the public in water. Boats and anchors hitting the cable may also contribute to damaging the cable, in similar installations.

- Incorporating submarine cable in maintenance programs to inspect and determine the condition of the outer covering and the concentric neutral of the submarine cable near shorelines.
- Replace aged cables to mitigate any hazards.
