# DEFECT OF THE MONTH

OCTOBER 2017

## Unused Openings and Missing Cover Plates

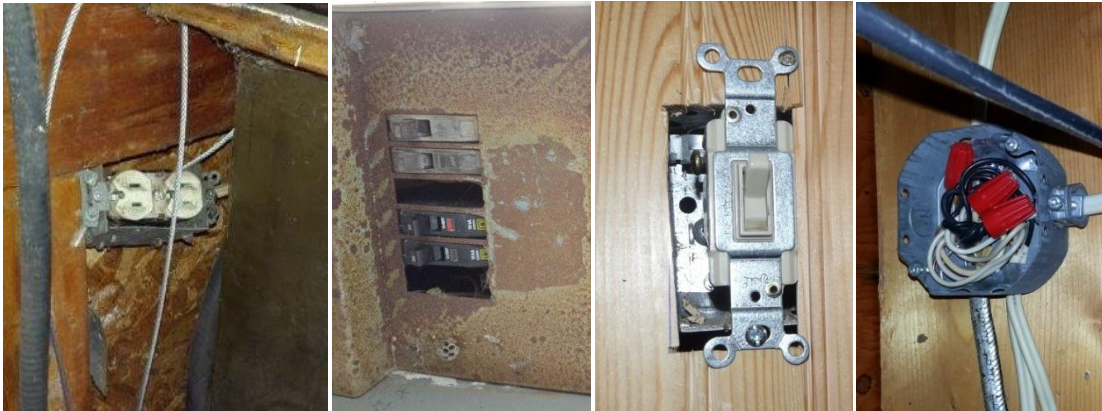
Missing cover plates or unused openings left unplugged in electrical enclosures with energized conductors – such as panel boards, electrical outlets, disconnect switches, etc. – represent a shock hazard to individuals that have access to this area. It can also be a fire hazard if an object falls inside one of these enclosures and causes an arcing fault between energized conductors or if the electrical device fails in close proximity to combustible. For example, a receptacle with missing cover plate may cause the adjacent wood panels to catch on fire in event of failure. The cover would usually mitigate that hazard.

ESA strongly recommends maintenance staff and facility operators perform periodic inspections to ensure unused openings in electrical enclosures are filled properly and all cover plates on electrical devices are in place.

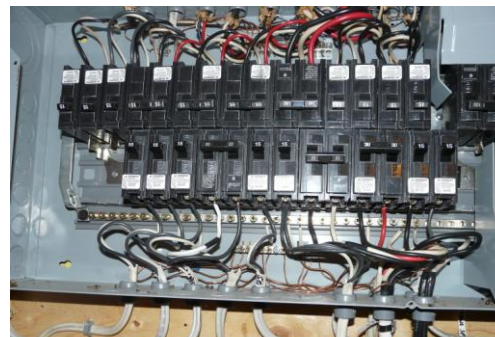
Over the past year, ESA inspectors have identified more than 1,700 defects regarding missing cover plates and unused openings in electrical enclosures. Rule 12-3024 of the Ontario Electrical Safety Code (OESC) requires unused openings in boxes, cabinets, and fittings to be effectively closed by plugs or plates affording protection substantially equivalent to that of the wall of the box, cabinet or fitting.
