4.5.2 Case Study: Fire Example #2 (continued)

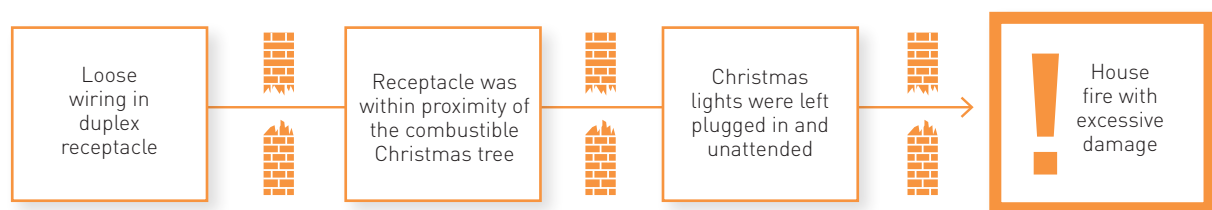
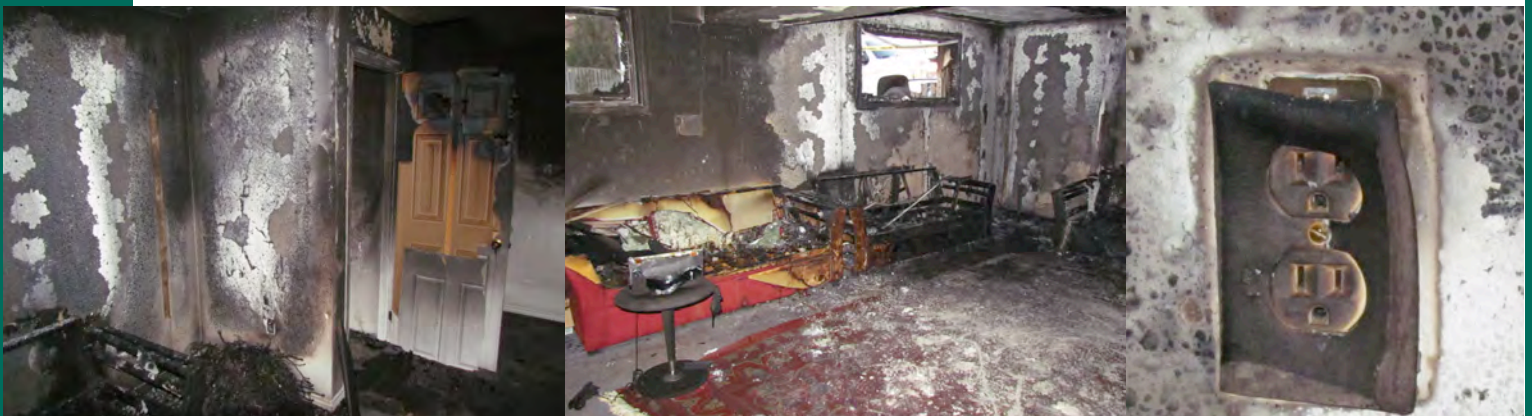
- A closet door adjacent to the south wall suffered severe charring and fire damage. The top of the door was compromised, allowing embers to enter the closet and ignite combustibles within the closet.

- The point of origin of the fire was determined to be the duplex receptacle along the short south wall in the recreation room – the receptacle that the Christmas lights were plugged into.

- No other viable or credible ignition sources were found.
- The cause was determined to be a loose or poor connection between the permanent wiring and one of the receptacle terminals, causing high resistance fault, charring the plastic components of the receptacle, resulting in parallel arcing.

- The arcing caused the projection of incandescent material from the receptacles, igniting the nearby natural Christmas tree and eventually igniting nearby furniture such as the sofas. The fire also spread to the closet just south of the area of origin.
